## Gardner House PROBE 7

Bill Bodass, John Field and Adrian Leaman report on how Gardner House, the penultimate building in our post-occupancy review series, has performed since completion. To understand the building's detailed design, readers must refer to the original article "Looking radiant", which appeared in the June 1994 issue of *Building Services Journal*.

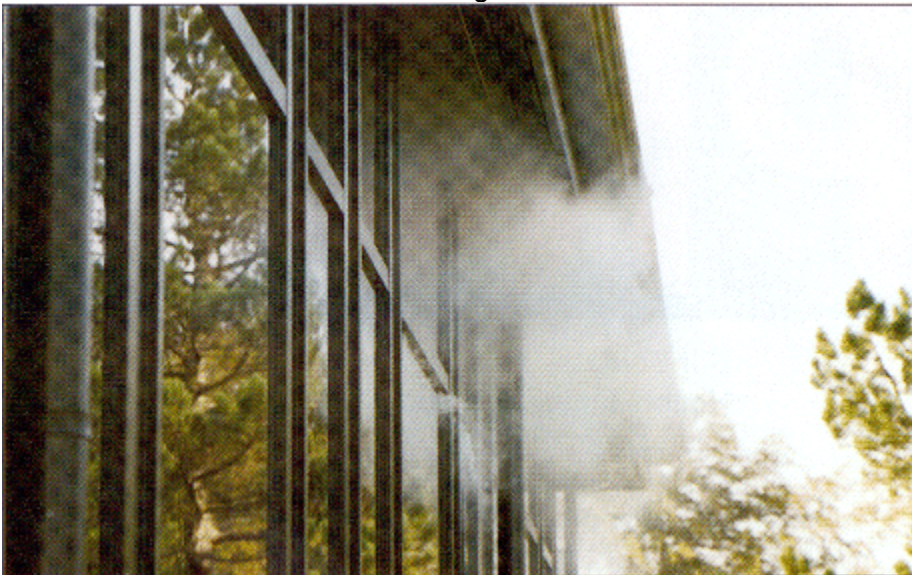
The first tests revealed major leakage at the eaves and at the cills to windows and curtain walling. Disappointingly, remedial measures reduced infiltration by less than 10%.

Attention then turned to the windows themselves. Tests by the manufacturers and BSRIA confirmed that large amounts of air could pass through labyrinthine paths in their hollow aluminium sections, and particularly up the mullions. *In-situ* foam filling and mastic sealing was carried out in the summer of 1996, and results of further pressure tests are awaited.

**Smoke released during the BSRIA's pressure tests showed severe leakage at eaves, cills and via the window system. Gardner house is not unusual though - the UK has an epidemic of new buildings which are not airtight.**

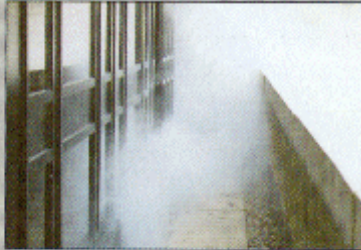
Tests revealed Gardner House to have an air leakage rate of 27 m<sup>3</sup>/h/m<sup>2</sup> at 50 Pa.

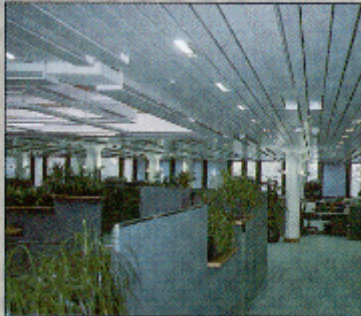
The pre-set blinds in the ground floor rooflight do not appear to have taken account of all oblique sun paths, and at certain angles there have been glare problems which have been partly resolved by rearranging furniture. As the rooflight also leaked initially and is a source of air infiltration, HFS's management feel that it could have been omitted.

The open-plan offices, with the rooflight in the foreground. The rooflight gives little sense of light and space to the large ground floor office, partly because the plane of the downstand baffles is maintained.

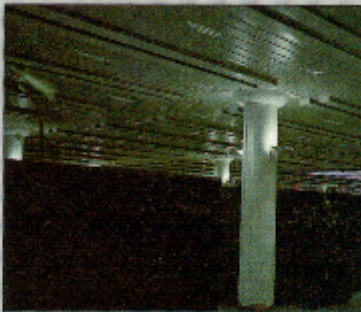
VDU screen glare was also mentioned, particularly from bright spots above the wall-mounted and column-mounted uplighters, and from their lamps at some angles. Remarkably, however, in 11 of 16 more detailed questions, occupant perceptions differed significantly from the norms. The building is perceived as colder and draughtier in both winter and summer, but surprisingly also stuffier. Further discussion suggested that this might be a comment on the fluctuations and on conditions during hot flushing. The building was also reported to be drier and more variable in temperature in summer (but not in winter) and much less smelly than average, both winter and summer.

Deliberately underexposed photograph to show the glare from the uplighters.
