# A LESSON FROM THE PAST

Experience gained from the post-occupancy evaluation of the National Trust's Heelis building have been fed into the design of The Woodland Trust's headquarters. The project team compares the in-use performance of both

By **Bill Bordass, Pete Burgon, Hester Brough, and Matt Vaudin**

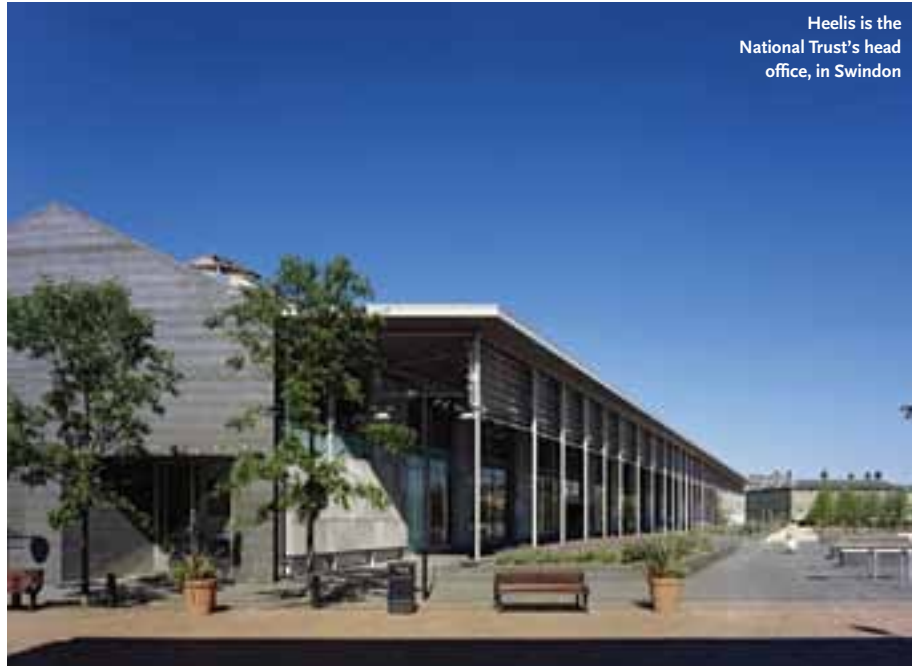
Heelis is the National Trust's head office, in Swindon

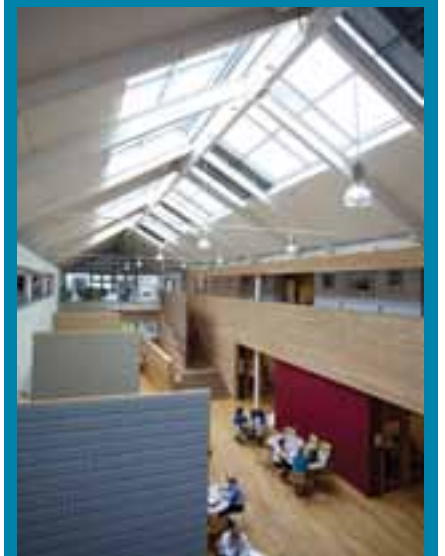
### ATRIUM AT HEELIS

This two-storey building relies extensively on roof lights – not just in the atrium, but in the office spaces around it, where there are also openings between the first and ground floors. The roof includes automatically controlled ventilation openings designed to achieve negative pressure under all wind directions, and an 83 kWp photovoltaic (PV) array. Note the external louvres to the south-facing offices to the right. Roof lights to the office areas are north-facing only, shaded by projections of the PV panels above the ridge.

- The design at Heelis optimised daylight factors (see box, 'Atrium at Heelis', right), but took less account of the brightness of walls and ceilings. As a result, some areas could feel gloomy when desktop illuminances were sufficient. Ambient lighting at The Woodland Trust, therefore, included wall-washing (see box, Woodland Trust: North Atrium, page 22).

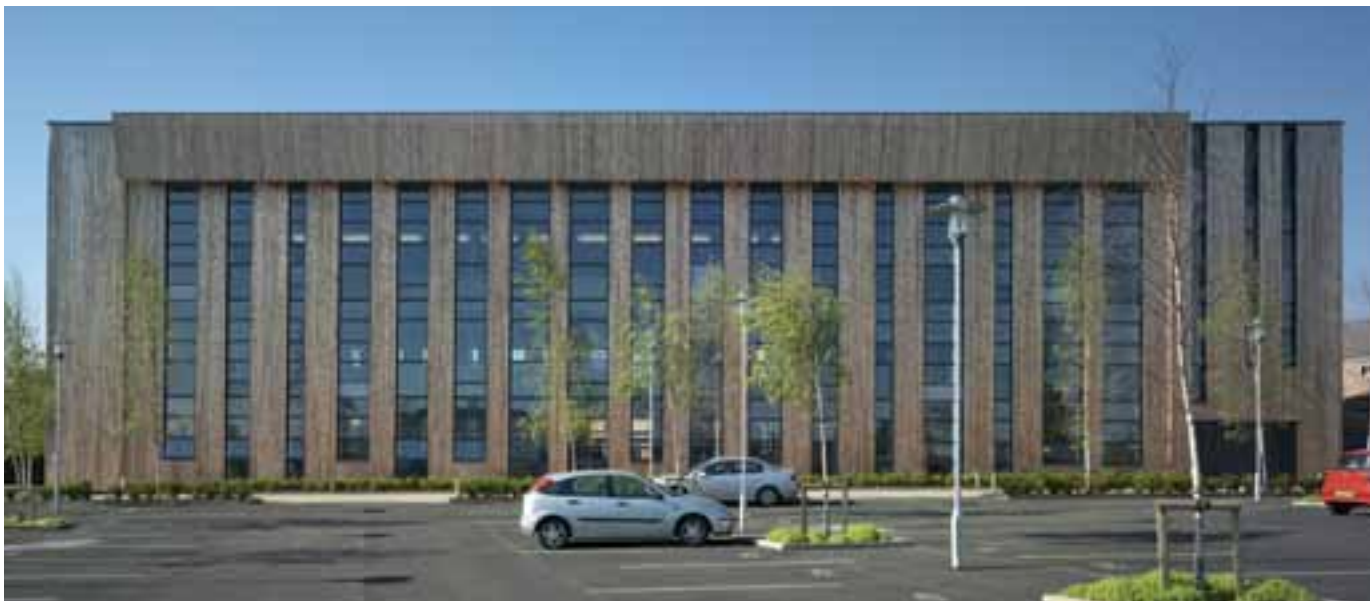
The Woodland Trust has a solid, cross-laminated timber structure, with external wood-fibre insulation and larch cladding

Woodland Trust, therefore, used a solid, cross-laminated timber (CLT) structure, with external wood-fibre insulation and larch rain-screen cladding. Concrete panels (known as concrete radiators) were also bolted onto the undersides of the CLT floors, to add stiffness and thermal capacity

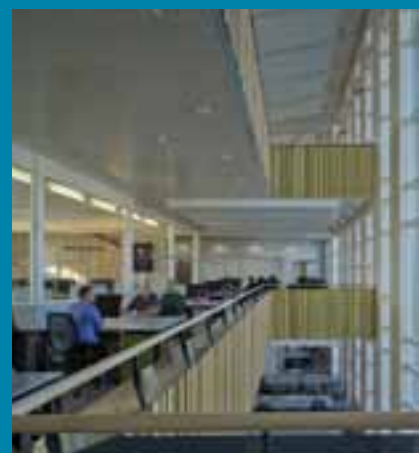
### THE WOODLAND TRUST: NORTH ATRIUM

Note the central steel columns and beams, and the concrete radiators to the left and in the background. Wall-washing lights can be seen on the west wall, with ambient lighting up the centre. The few splashes of light on the ceilings indicate that most of the task lights were off.
