# One Brighton

This document contains a Building Performance Evaluation report from the £8 million Building Performance Evaluation research programme funded by the Department of Business Innovation and Skills between 2010 and 2015. The report was originally published by InnovateUK and made available for public use via the building data exchange website hosted by InnovateUK until 2019. This website is now hosting the BPE reports as a research archive. As such, no support or further information on the reports are available from the host. However, further information may be available from the original project evaluator using the link below.

<b>Innovate UK project number</b>	450009
<b>Project author</b>	Good Homes Alliance
<b>Report date</b>	2014
<b>InnovateUK Evaluator</b>	Tom Kordel (Contact via <a href="http://www.bpe-specialists.org.uk">www.bpe-specialists.org.uk</a> )

One Brighton is a mixed-use development comprising residential blocks with office and community space. Five apartments were monitored, with fabric testing and an occupant survey. The buildings have an efficient thermal envelope, and use sustainable construction materials and low-energy appliances. Biomass and gas

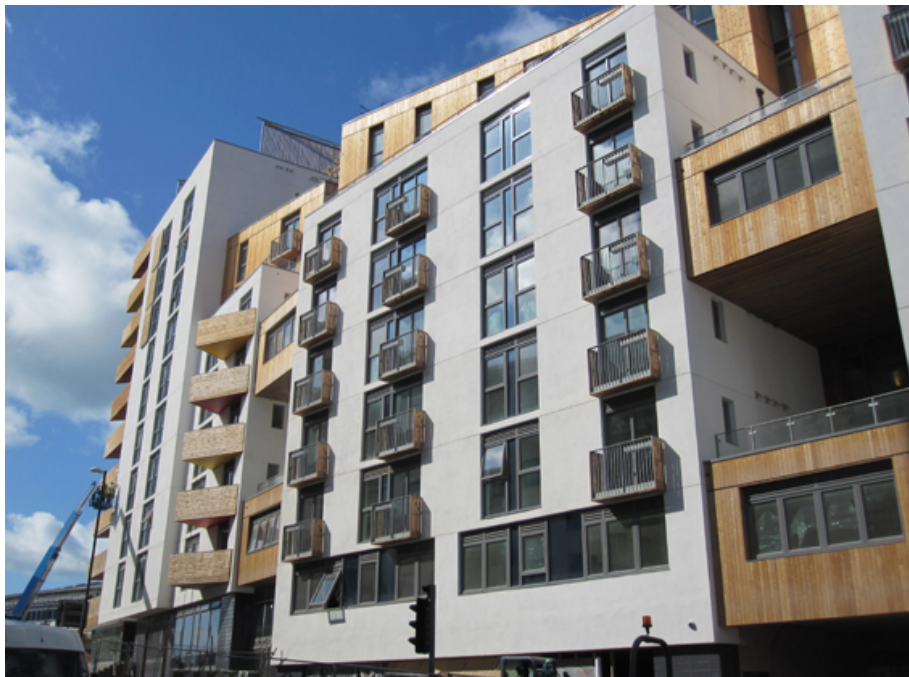
**Figure 2 – One Brighton Development (Brighton Belle Block East Facade)**

The completed development is shown in Figure 2.

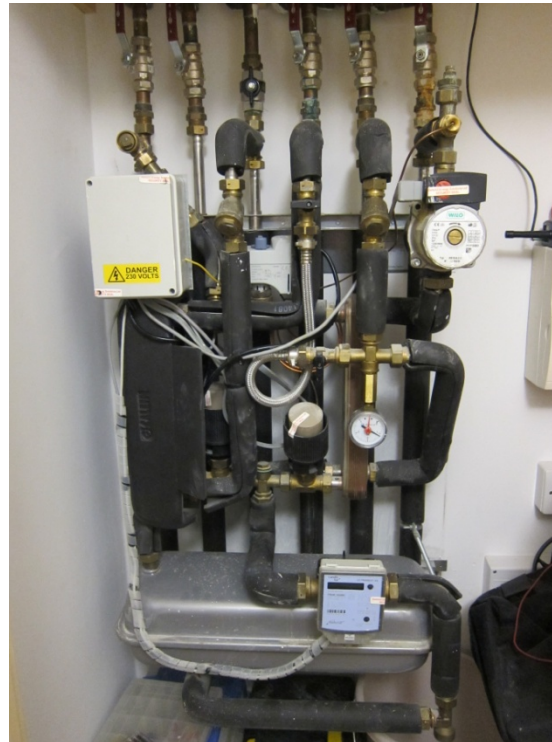
**Figure 4 – Heat Interface Unit**

distribution pipes in a set of service risers, and tertiary horizontal distribution pipes at high level in corridor ceilings. These are connected to Heat Interface Units (HIU) located in each apartment. The installed unit is a Switch 2 indirect Type 3 Mini HIU (see Figure 4). The HIU contains two indirect circuits, each with their own heat exchanger to hydraulically separate the communal system from the dwelling heating circuits. A heat meter is fitted to the communal main input to the HIU in order to provide consumption data for billing purposes.

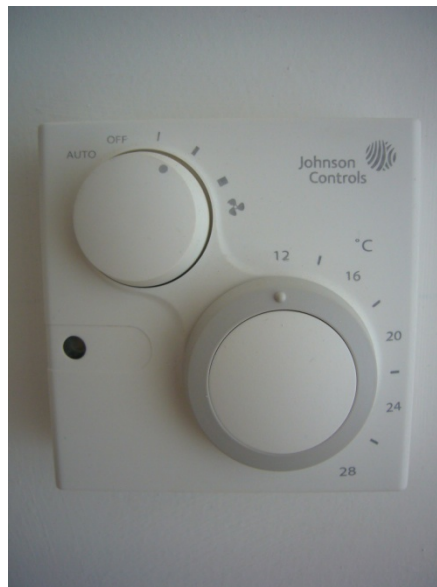
Figure 6 – MVHR and Heating Controls in Dwelling

Space heating within the apartments is delivered by warm air provided through the MVHR system. A heater matrix linked to the HIU is fitted to the supply air side of the MVHR heat exchanger (see Figure 5), with warm air provided via the air valves in the living room and bedrooms of the apartments. Instantaneous domestic hot water is supplied via a heat exchanger in the HIU. Control of the heating system is achieved using a combined control for temperature and MVHR fan speed as shown in Figure 6. The installed MVHR unit is an Xpelair Xcell 600 system. The fans have 3 speed settings. Speed I on the controller is the trickle mode and speed III is the boost mode. The boost mode is also activated when the light switch was on in the bathrooms.

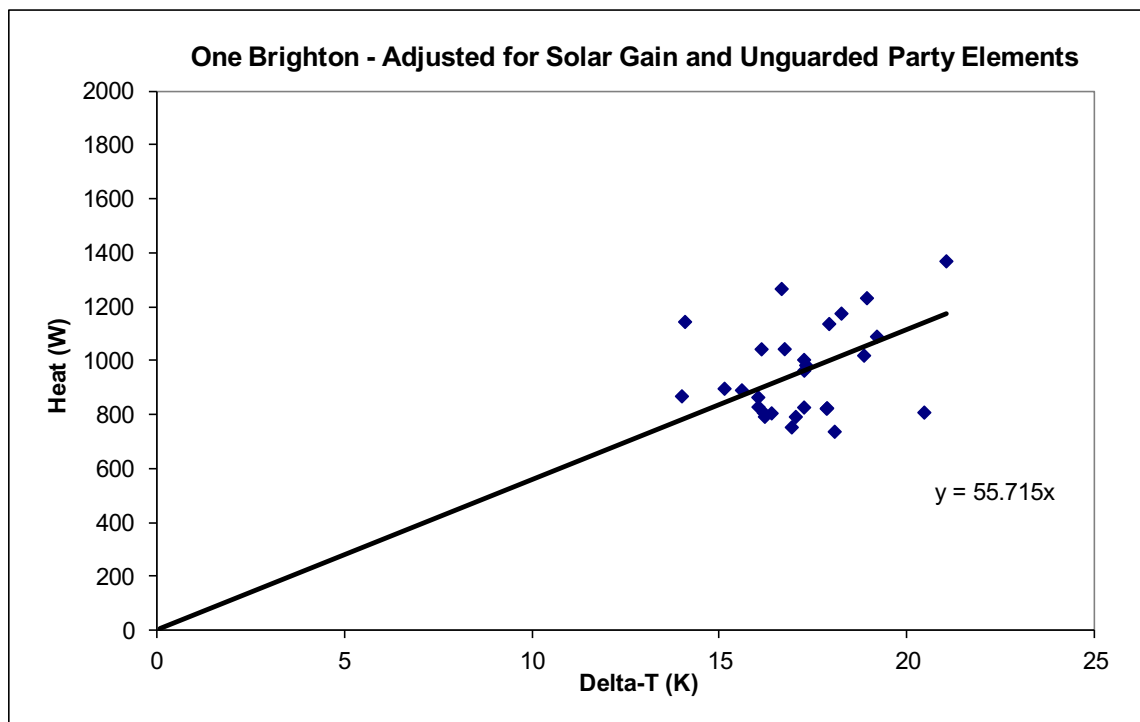
The plot of the adjusted daily heat input data versus the inside-outside delta-T is given in Figure 11. The intercept of the fitted linear regression line has been forced through the origin. It can be seen that there is a high level of scatter of the data points, which is not unexpected given the experimental difficulties and other uncertainties associated with tests on apartments. The regression analysis with heat as the dependent term gives the heat loss coefficient as 55.7 W/K with a standard error from the regression process of 1.9 W/K. Note that this error term excludes instrument errors and errors due to heat exchange with other apartments and the circulation space, so will underestimate the total error in heat loss coefficient. A comparison of the measured heat loss with the predicted heat loss (see Table 8) shows that the measured total heat loss coefficient is 19 W/K (52%) higher than the prediction. As the prediction includes the measured value of background ventilation heat loss, then the difference is all attributable to the fabric performance. The 19 W/K measured discrepancy in heat loss is therefore equivalent to a factor of 86% over the predicted fabric heat loss of 22.1 W/K.

Figure 11 – Coheating Heat Loss Plot adjusted for Solar Gain and Unguarded Heat Loss

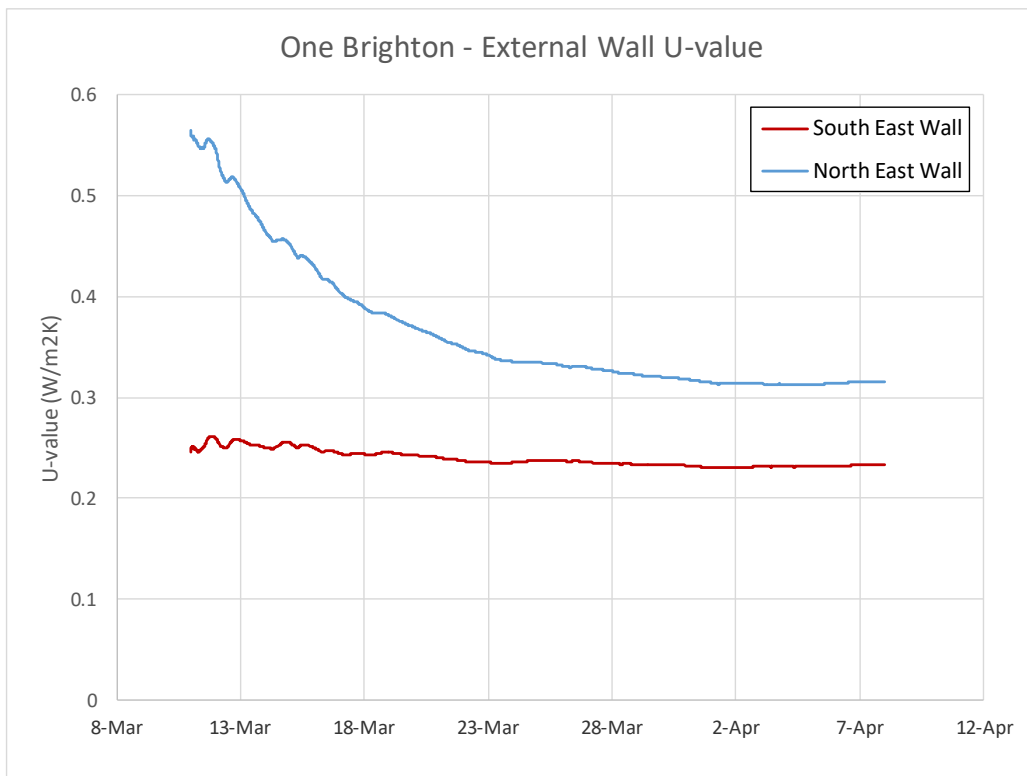
**Figure 14 – In-situ U-value Cumulative Average Measurements over Time**

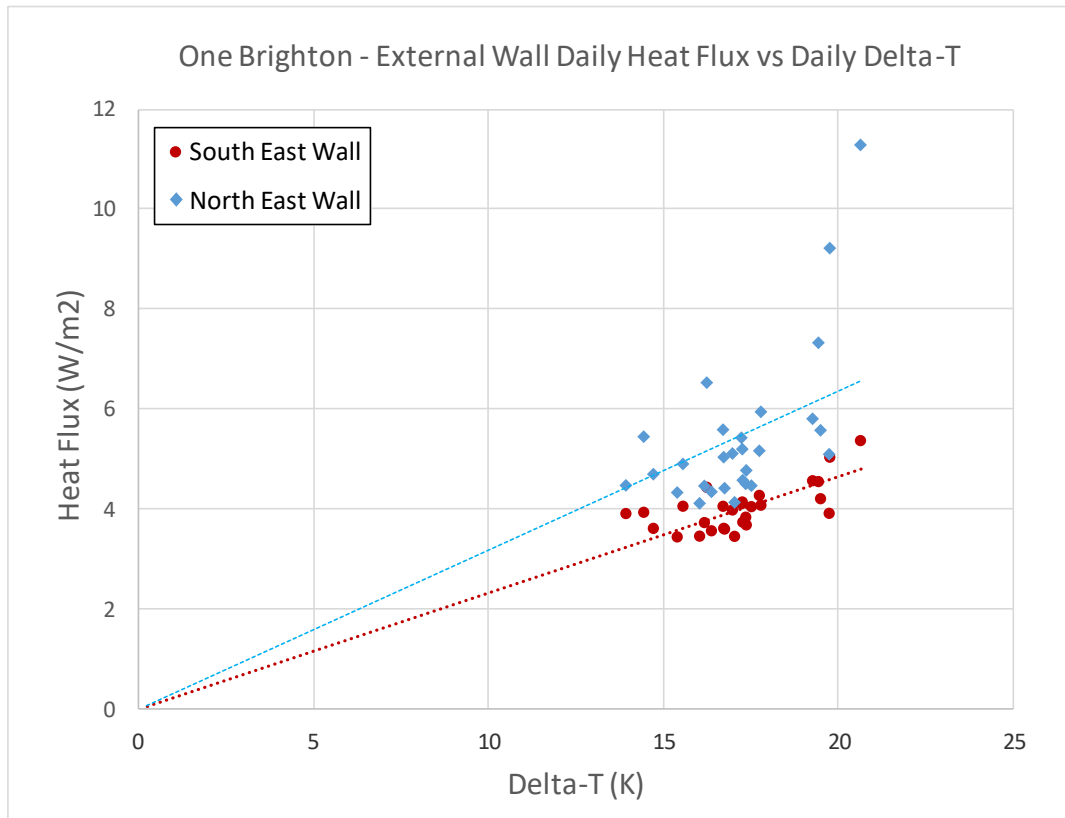
In order to assess the scale of measurement error for the in-situ U-values, the heat flux data for the two sensors were plotted against the inside-outside temperature difference as daily averages (see Figure 15). The data were then analysed using a linear regression, with the intercept forced through the origin. The regression coefficients for the slope (U-value) and standard error are shown in Table 10. For the south east sensor the standard error is of the order 2%, and for the north east wall the error is slightly higher at 5%, giving good confidence in both U-value measurements.

Figure 15 – In-situ U-value Measurements: Mean Daily Heat Flux vs. Mean Daily Temperature Difference

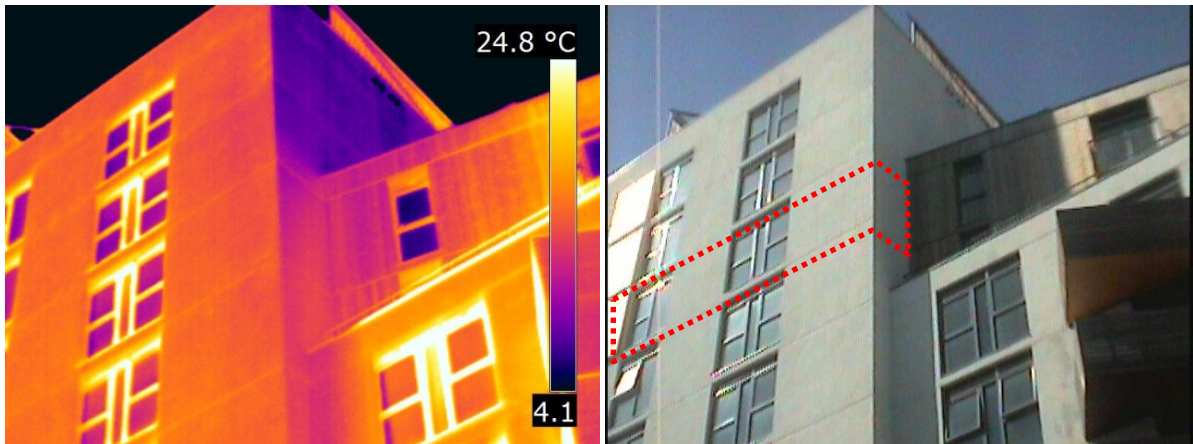
A limited thermal imaging survey was carried out on the Coheating test apartment. The survey was conducted using a FLIR P60 infra-red thermal imaging camera. The thermal images in Figure 16 and Figure 17 show the external façade of the Coheating test apartment (location of test apartment is shown by the red dotted line on photographs). The external thermal images show no discernible thermal defects or anomalies, even after post-processing the images to look for small surface temperature differences. This is perhaps surprising, as it would be expected that it would be possible to identify the thermal bridges at the floor junctions and at the locations of the concrete columns. The conditions at the time of the imaging survey were however not ideal. The inside-outside temperature difference was of the order 10K, which is generally considered sufficient for thermal imaging. However, the images were taken on a sunny day, and solar effects would have likely masked any surface temperature differences arising from heat flow through the walls. In addition, the acute observation angle of the façade from the ground would also have caused problems.

Figure 17 – Thermogram and Photograph of South East Wall of Co-heating Test Dwelling

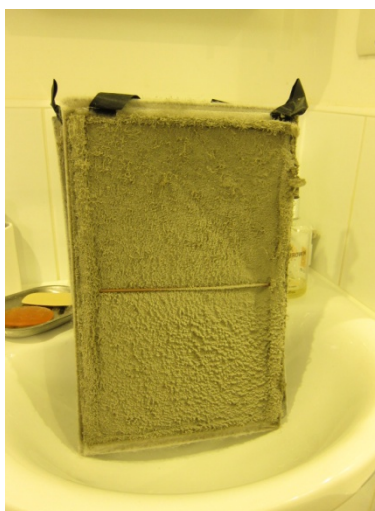
**Figure 23 – Dirty MVHR Filter from Dwelling B**

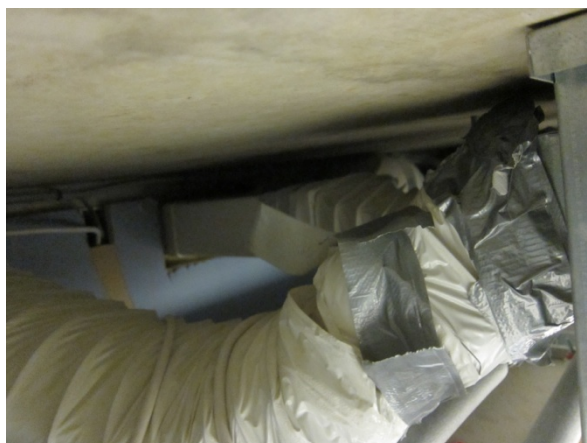
The total flow rates in trickle mode in dwelling (see Table 22) ranged from 13 l/s for extract to 16 l/s for supply. These rates are at least double the total trickle flow rate required by Part F 2006 for this dwelling (6.4 l/s) and indicates a degree of over-ventilation, with the potential for higher energy consumption than necessary for acceptable levels of fresh air. The results also indicate that the flow rates may have not been commissioned in accordance with the design flow rates although, as commissioning certificates were not provided, it is not possible to confirm that this was the case. Observations made at the same time as the Diff flow measurements showed that the MVHR filters were excessively dirty and clogged with dust (see Figure 23). The filters were cleaned, and this resulted in an increase in the extract flow rate of 20 l/s, but interestingly only a small increase in the supply flow rates. This clearly demonstrates the importance of regular maintenance of MVHR filters. Issues were also observed with poorly taped connections between flexible ducting connected to the MVHR unit (see Figure 24), indicating poor installation or maintenance practice and a lack of effective supervision. Gaps in the duct joints will have a significant effect on the performance of the MVHR system.

**Figure 24 – Gap in Connection between Flexible Ducting in Dwelling B**

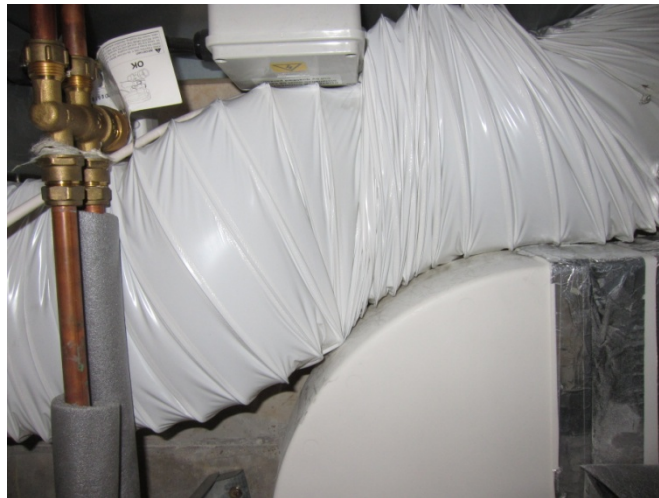
Observations made at the time of the flow measurements revealed that many of the flexible ducts leading to the MVHR units were constricted, damaged or crushed (see example from Dwelling 62 in Figure 25). It is imperative that, where flexible ducting is used in preference to rigid duct, it is fully extended and not constricted so as to minimise the effect on duct resistance. Current guidance from the NHBC (NHBC 2013) is to use rigid duct for the majority of the system, and to only use flexible duct in short lengths (maximum 300mm) to make the final connections to air valves and fan units. High duct resistance will lead to increased fan energy consumption. It was also noticed that some of the kitchen air valves had a build up of visible fat deposits (see Figure 26). These fat deposits will also build up inside the duct work. The effect of this will be to increase the duct flow resistance. The underlying cause of this issue is that the kitchen air valves will have been located too close to the hob and oven, coupled with the absence of an effective, or underutilised extract fan from the cooker hood. It is perhaps a good idea to suggest to both the residents and social landlord that cleaning of the kitchen valves should be included as part of the MVHR maintenance regime.

**Figure 25 – Crushed Flexible MVHR Ducting in Dwelling 62**

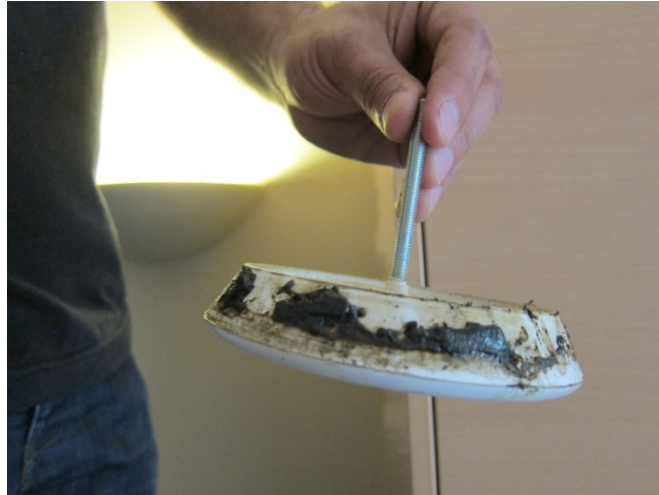
**Figure 26 – Fat Deposit on Kitchen Air Valve**

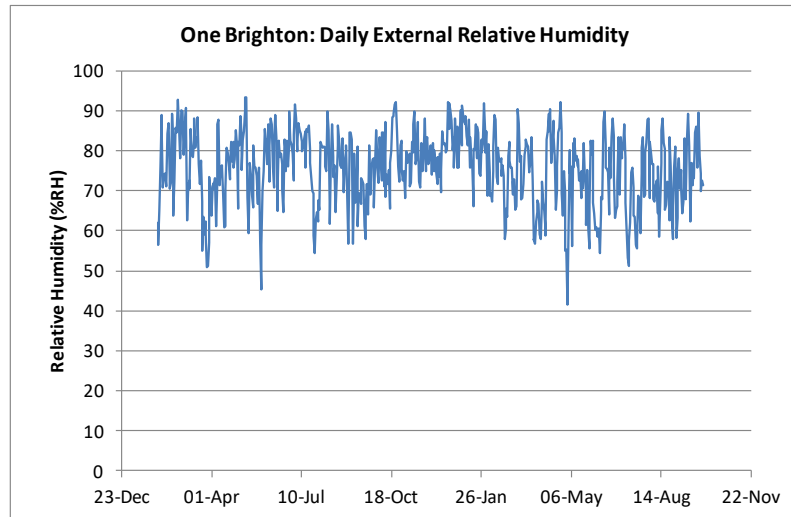
Figure 32 – Graph of Daily External Relative Humidity at One Brighton Feb-12 to Sep-13

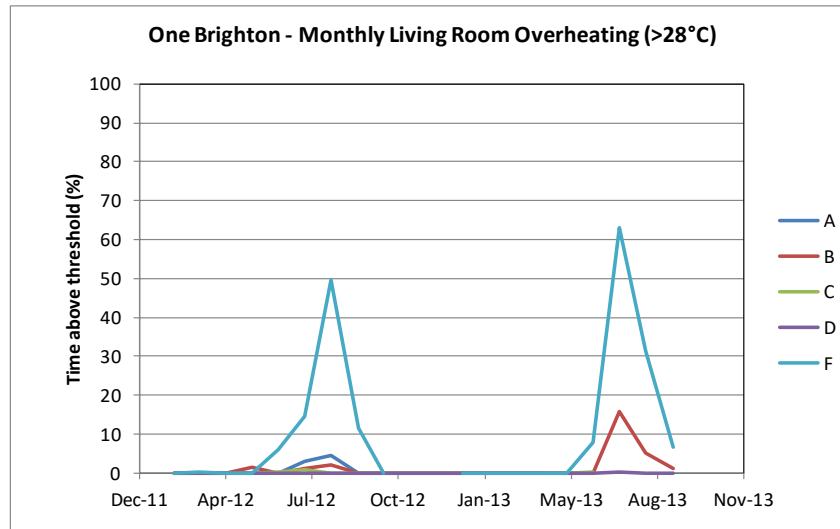
In order to assess the overheating potential of the dwellings, an analysis was undertaken using the CIBSE overheating peak threshold temperatures of 28°C for the living room and 26°C for the bedrooms (CIBSE 2006), for which 1% of hours is given as the acceptable limit. The percentage of time the internal temperature exceeded these thresholds was calculated on a daily basis during the summer for the living room and bedroom in all five monitored apartments. The graphs in Figure 34 and Figure 35 show the percentage of time above the overheating threshold by month for the bedroom and living room for the five apartments. There is some limited overheating in the living room of apartment F. However, the bedrooms of all five dwelling regularly exceed the 26°C threshold. The overheating data were annualised for the period February 2012 to January 2012 in order to compare the results with the CIBSE annual 1% limit (see Table 34).

Figure 35 – Percentage Time above CIBSE Overheating Threshold in Living Room by Month

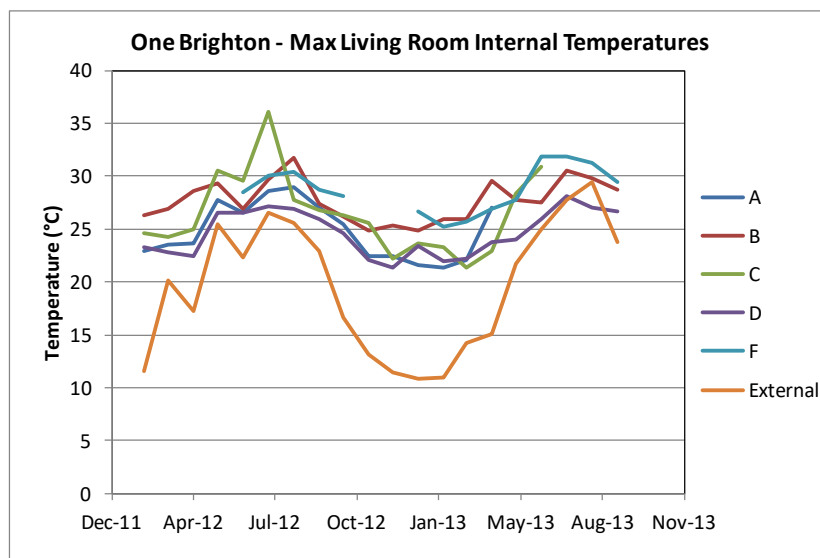
Figure 37 – Maximum Living Room Temperatures by Month

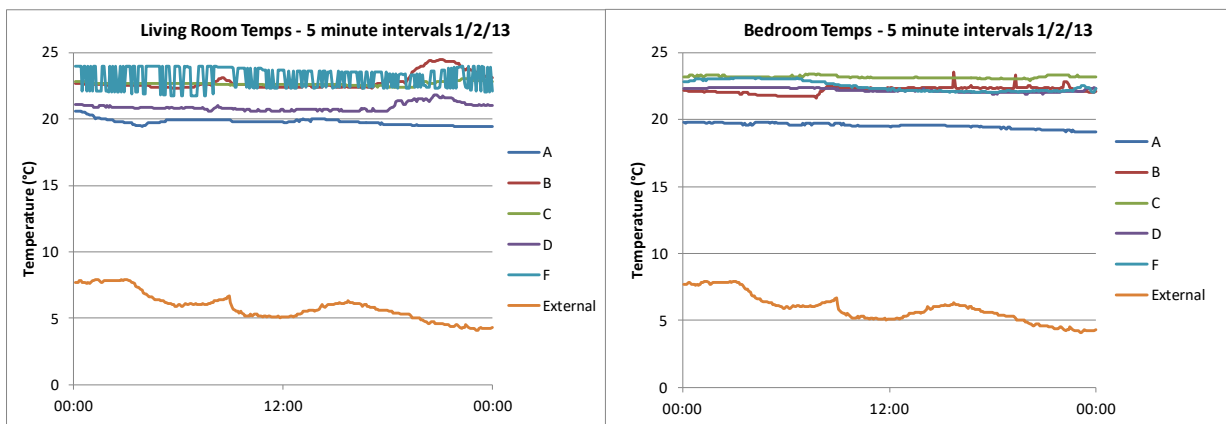
The 5-minute internal living room and bedroom temperature data for all five dwellings for the 1<sup>st</sup> of February 2013 were compared to identify any difference in diurnal patterns in winter time (see graphs in

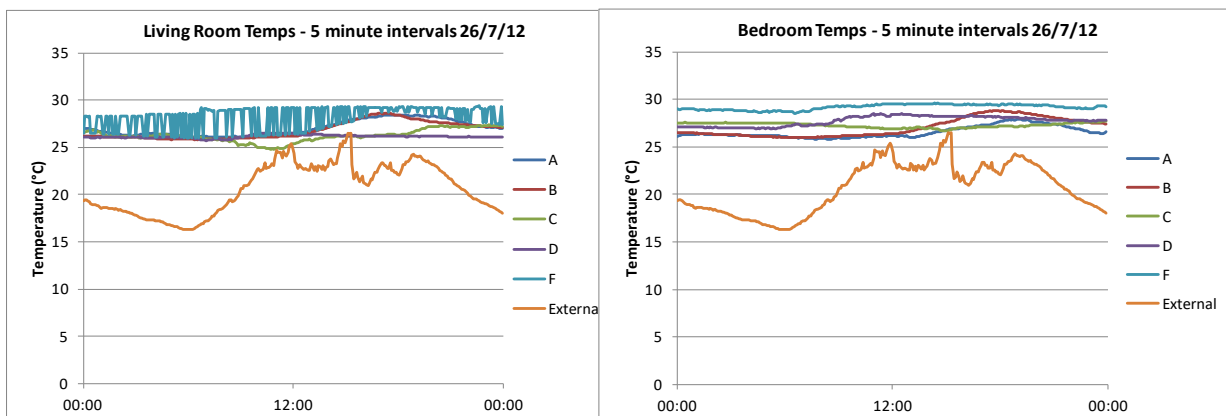
The 5-minute internal living room and bedroom temperature data for all five dwellings for the 26<sup>th</sup> July 2013 were compared to identify any difference in diurnal patterns in summer time (see graphs in Figure 39). It can be seen that the temperatures in the living room and bedroom are stable for the first part of the day. The temperatures start to rise in response to the high external temperatures and probably solar gains in the afternoon, and peak at around 17:00. There was no correlation between high internal temperatures and measured window opening behaviour.

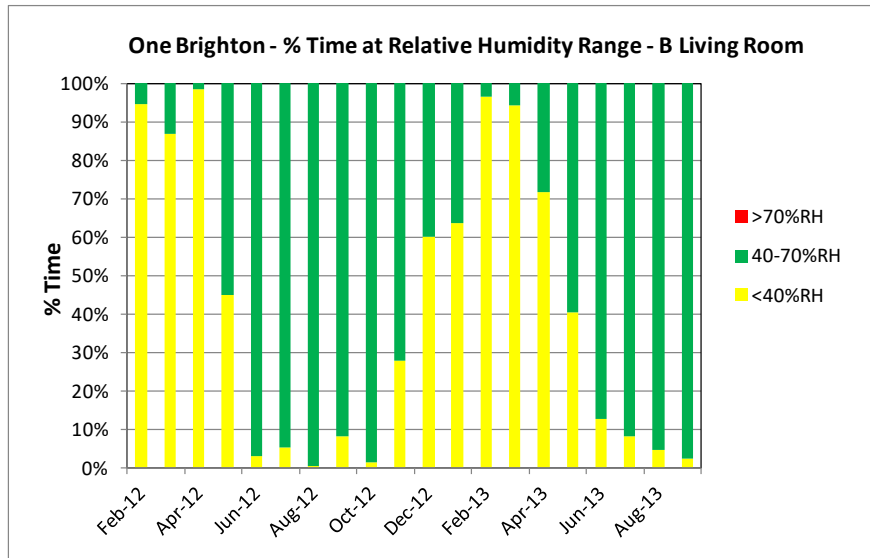
Figure 42 – Dwelling B Living Room % Time at CIBSE Relative Humidity Range by Month

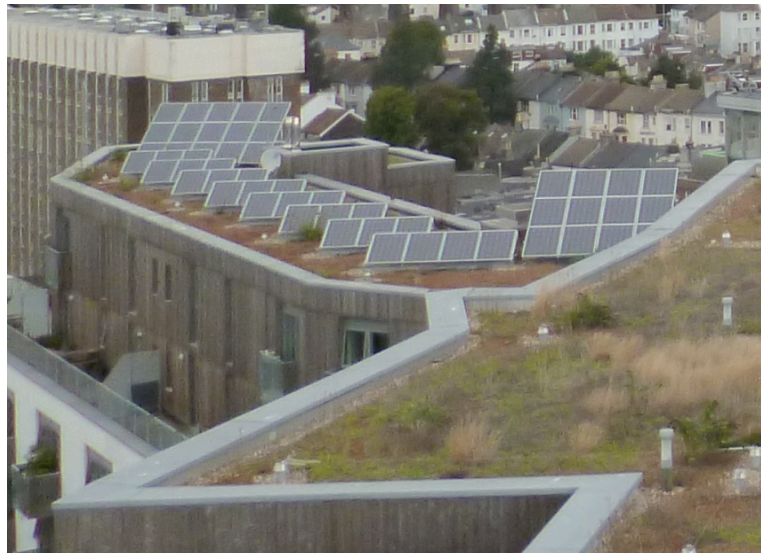
**Figure 75 – PV Array on Roof of Pullman Haul Building at One Brighton**

The photovoltaic (PV) panel array at One Brighton consists of 52 Sharp NU 180 modules. These are fitted to the roof of the Pullman Haul building (see Figure 75), and are oriented due south with a tilt angle of 45°. The modules are monocrystalline silicon with a nominal output of 180 Wp per module, giving a total design output for the array of 9.36 kWp. The panels are all 1.318 m x 0.994 m in size, giving a total area for the array of 68.1 m<sup>2</sup>. The panels are linked to the private wire system for the development via three Fronius IG30 inverters, with 3 kWh meters recording the output from the array. The kWh meters were not connected to any datalogging devices, so the performance of the system has been assessed using a series of monthly manual meter readings taken in the early years of the development (October 2009 to April 2011), together with final manual readings taken in September 2013.

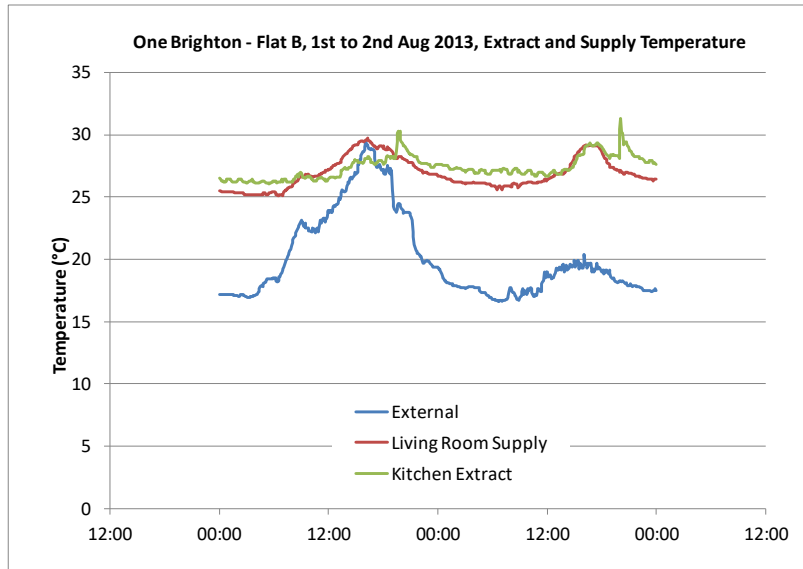
The graph in Figure 80 shows the 5-minute temperature data for the living room supply and kitchen extract in dwelling C for the 1<sup>st</sup> August 2013, when the external temperature peaked at 29°C. It can be seen that, when the external temperature dropped to around 17°C overnight, the supply temperature remained high, indicating that the automatic summer bypass dampers in the MVHR unit are not operating to take advantage of free-cooling. The operation of the MVHR system should be checked by the building manager.
