St. Peter the Apostle High School

Innovate UK project number	450045
Project lead and author	BAM Construct UK Ltd
Report date	2014
InnovateUK Evaluator	Tom Kordel (Contact via www.bpe-specialists.org.uk)

Building sector	Location	Form of contract	Opened
Schools (secondary)	Clydebank	Design and build	2009
Floor area	Storeys	EPC / DEC	BREEAM rating
16,185 m ²	3	B / N/A	Very good

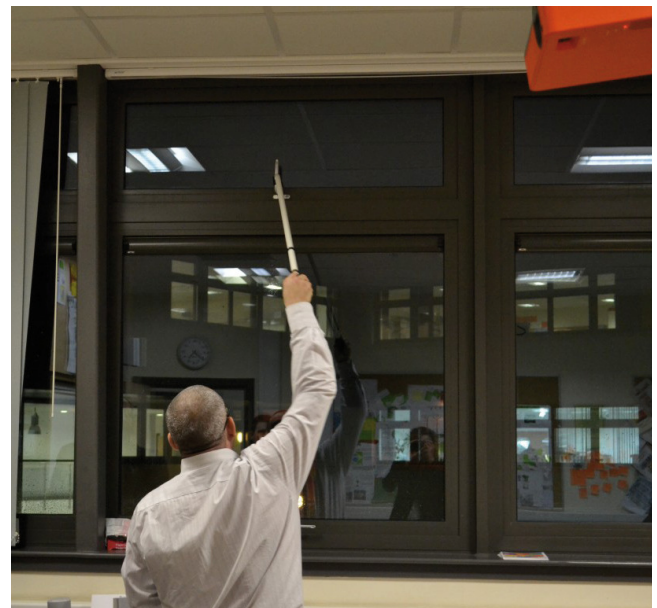
The use of only the upper section was to ensure that the room occupants do not experience significant flow rate and draughts of untreated cold air whilst still providing fresh air for ventilating purposes. All windows are opened via standard handles. A pole is provided in each classroom to operate the high level window pane.

Figure 3.2 - Typical classroom window showing the openable top pane and bottom pane as well as the opening pole being used

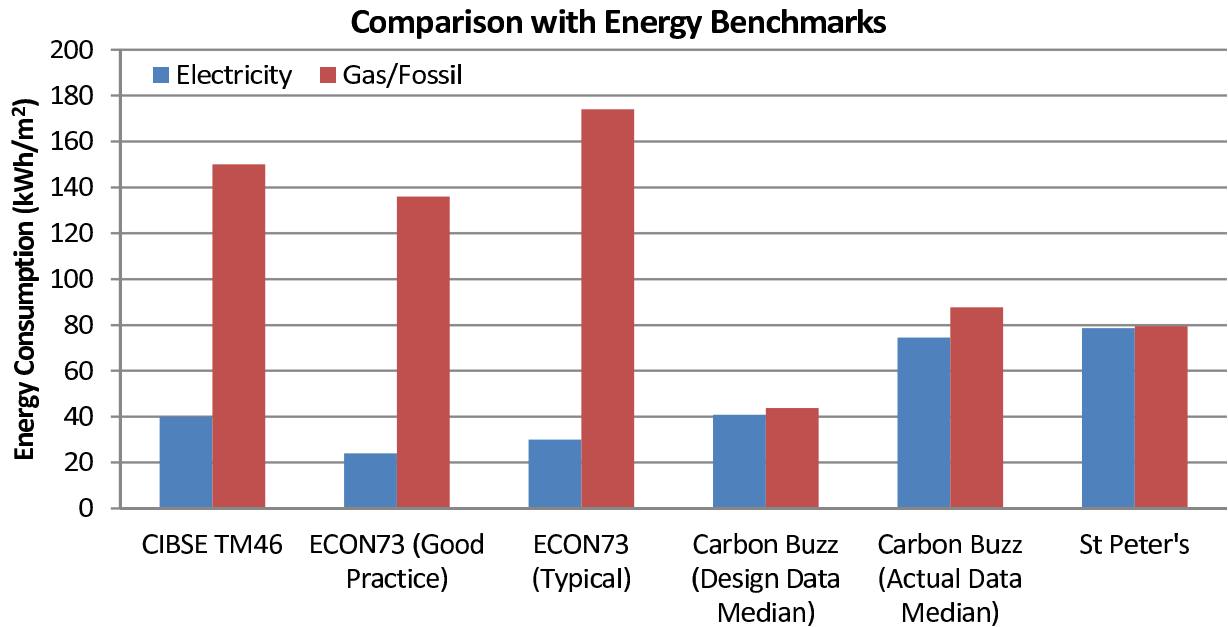
A further difference from TM46 and ECON73 is the higher electricity consumption observed within St Peter School. It is possible that newer schools typically use much more electricity to operate equipment than previously established by the 1997 and possibly 2008 benchmarks due to the higher IT demands of a modern curriculum. It should also be noted that the school is overcrowded with respect to the design occupancy and therefore it is likely that the larger amount of pupils and associated staff would lead to higher electricity use for small power and IT.

Figure 6.1: Energy benchmarking against Carbon Buzz, TM46 and ECON73 data based on a TM22 simple assessment.

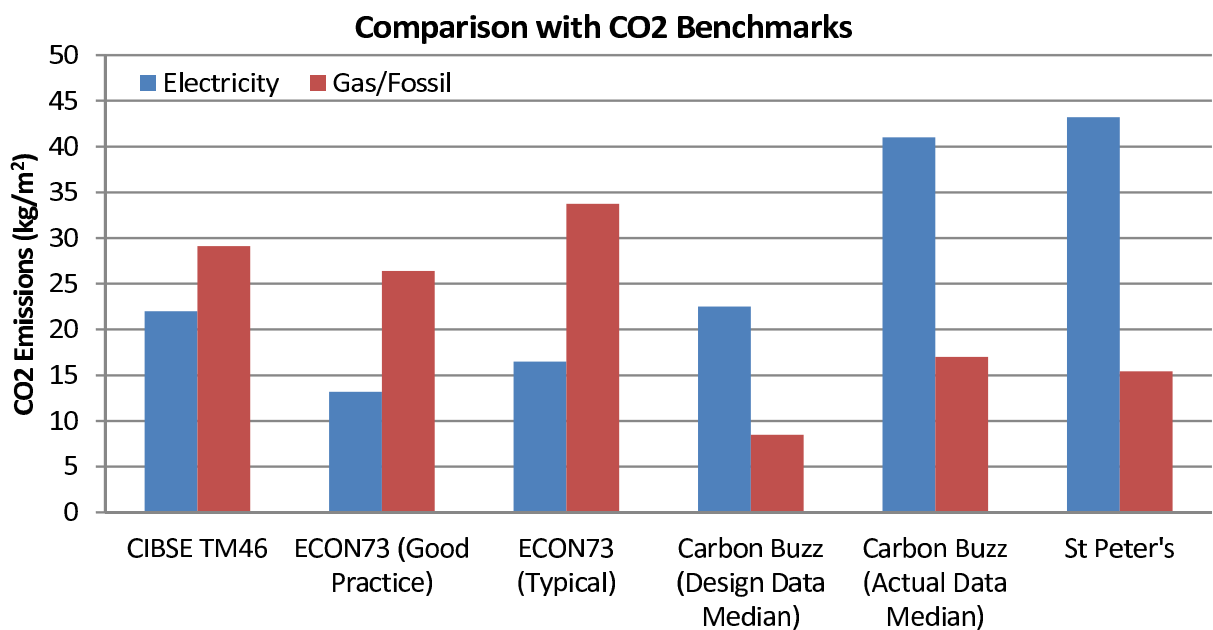
Converting the data into CO₂ emissions makes the electricity use much more significant due to the higher carbon factor of electricity. TM46 and ECON73 benchmarks show much lower emissions from electricity than both Carbon Buzz and St Peter School. In contrast, the gas/fossil emissions are much lower in the Carbon Buzz and St Peter data.

Figure 6.2: Energy and CO₂ benchmarking against Carbon Buzz, TM46 and ECON73 data based on a TM22 simple assessment.

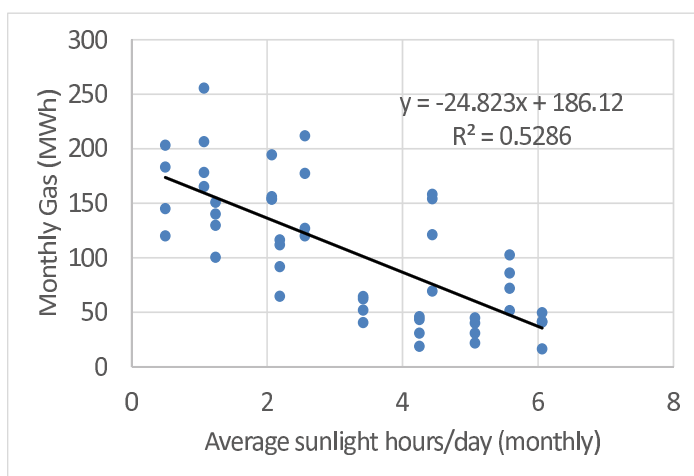
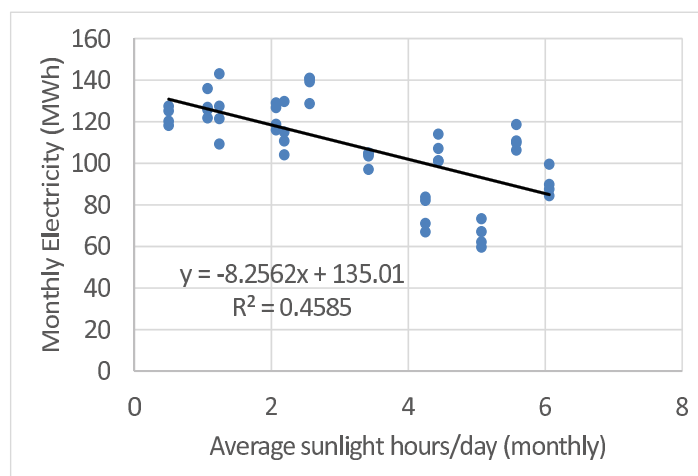
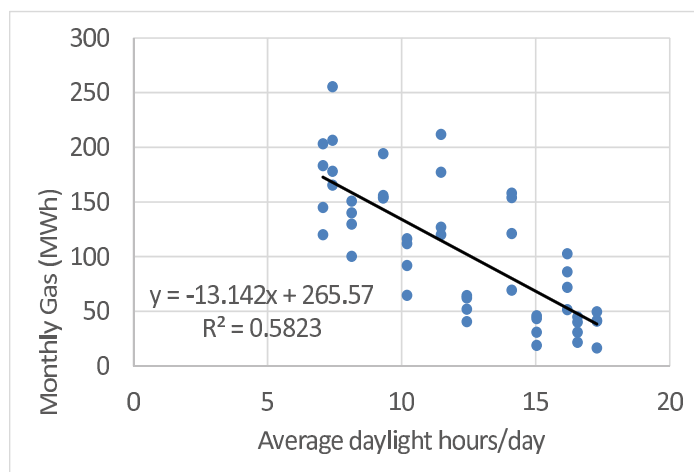
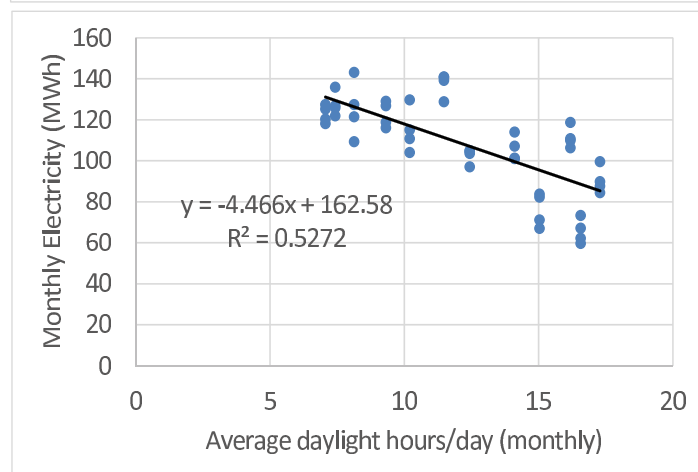
As well as sunlight and daylight analysis, figure 6.9 also looks at the relationship between electricity consumption and heating degree days. This correlation is also relatively strong, and is probably due to some electricity consumption being used for the ground-source heat pumps. The sunlight and daylight relationships are less strong, which may suggest that the daylighting strategy may not reduce electrical load as much as was hoped.

Figure 6.9: Further HDD, sunlight and daylight analysis for electric and gas consumption

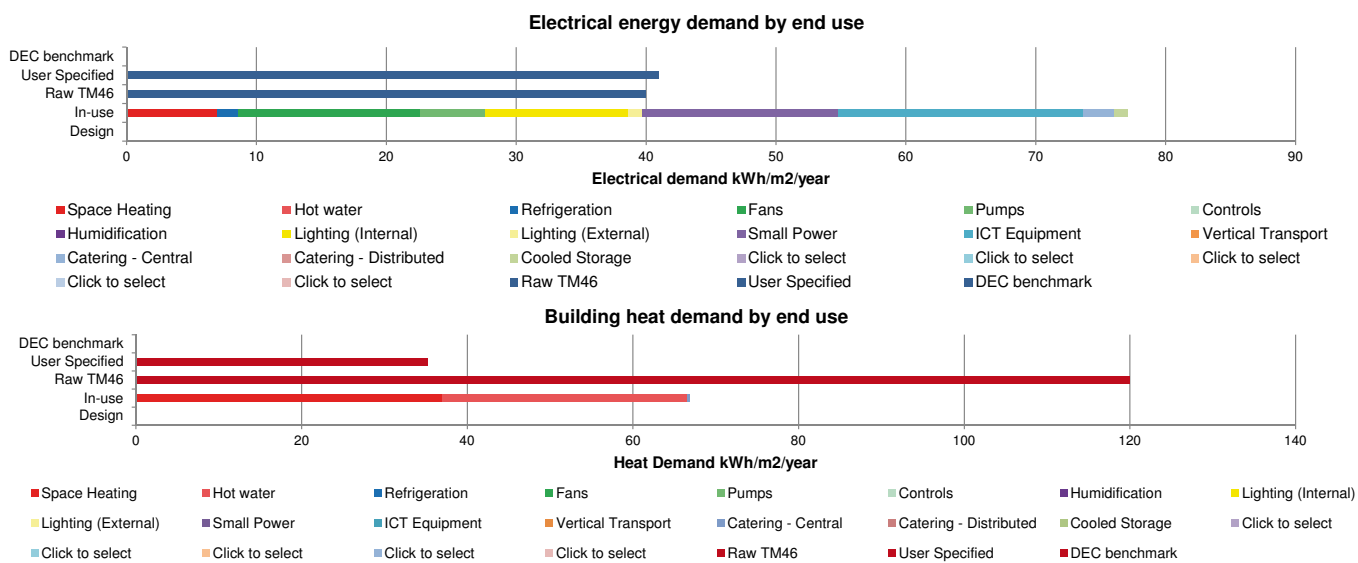
Figure 6.10: TM22 detailed analysis including splitting of end-uses based on energy profile estimates rather than accurate sub-metering

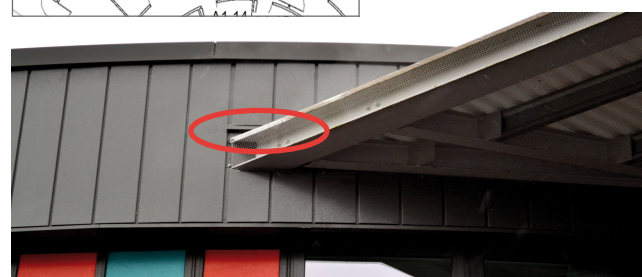
Figure 7.1: Location of leakage found in the rotunda during the smoke box test.

During the smoke box test carried out at Room A1.10, a significant amount of smoke was to be observed emerging from the connection between the roof above Room A1.10 and the adjoining external overhang for the building entrance. This may be due to the presence of an air gap between the two elements (see figure 7.1). Further investigation should be carried out to determine the cause of excessive air leakage at this location and then rectify the defect. It is probable that the infiltration at this point is impacting the comfort in room A1.10 and also increasing heating energy use. Thermal imaging was also carried out as part of the BPE study in order to highlight any further areas of

Junction between ceiling of room A1.10 and overhang near building entrance where leakage was detected
