PROJECT REVISIT
How is the **Centre for Mathematical Sciences** faring six years on? **Page 10**

THE PROBE PROJECT

Chris Parkin and Roderic Bunn revisit the Centre for Mathematical Sciences at Cambridge University to find out how the campus buildings have performed over the long term

BSRIA PROJECT REVISIT

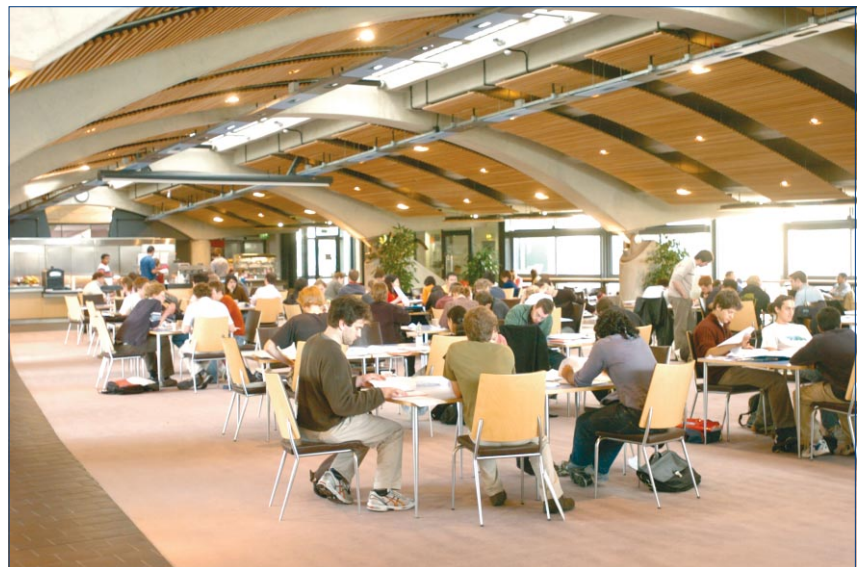
Above: The popular cafeteria behind the entrance of the grass-covered Pavilion A. Six years after occupation the Pavilions appear to have worn extremely well.

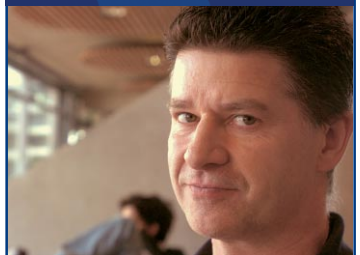
Centre for Mathematical Sciences assistant facilities manager **Mick Young** experienced problems with over-driven window actuators.

"We would hear windows clicking as chains were slipping over the cogs," said Mick Young. "We've resolved it, but we think it's up to the industry to solve those kind of problems."

For a site with hundreds of window-opening motors and actuators, the system has proved robust. However, in Pavilion A, virtually every window motor has been replaced since 2001. The new motors have software that only drives the motors for a certain period. This prevents the motors trying to push the actuators beyond the point of maximum window opening. For the earlier motors, a pressure sensor would sense that the window was fully open. When those sensors failed, the motors would continue to drive the actuators, forcing gears to slip over the chains.
