## Gardner House PROBE 7

Bill Bodass, John Field and Adrian Leaman report on how Gardner House, the penultimate building in our post-occupancy review series, has performed since completion. To understand the building's detailed design, readers must refer to the original article "Looking radiant", which appeared in the June 1994 issue of *Building Services Journal*.

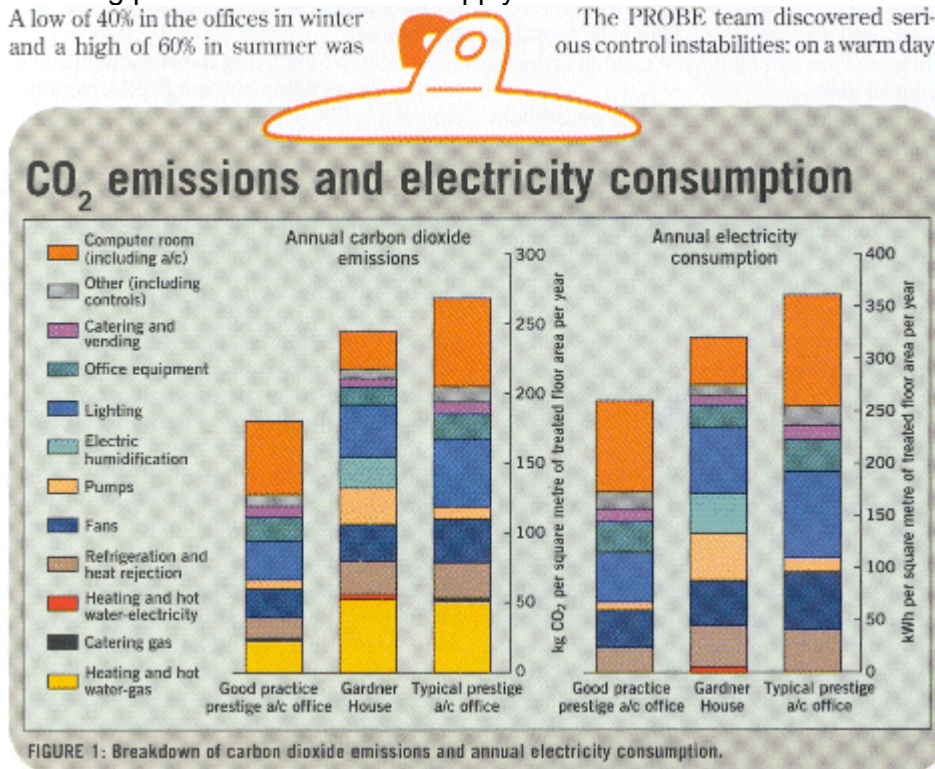
There have been difficulties in obtaining the intended amount of humidification. A low of 40% in the offices in winter and a high of 60% in summer was intended, but during the first winter rh levels sometimes fell to nearly 30%, leading to staff complaints, particularly from contact lens wearers.

When investigated, the canisters of the electrode boilers were found to have been rapidly degraded by salts and corrosion, and were operating well below their design output (canisters are now replaced twice a year). However, the replacements have not provided the full specified output, a problem which has been attributed to the low conductivity of the soft local water.

The PROBE team discovered serious control instabilities: on a warm day (outside air temperature 25–26°C) the main air handling plant cycled over a half-hour period from full cooling, via full cooling plus reheating, full reheating with no cooling, to full reheating with humidification and back to full cooling.

A low of 40% in the offices in winter and a high of 60% in summer was

The PROBE team discovered serious control instabilities: on a warm day

Meanwhile the rh set-point has been raised, but this leads to wasteful operation at times when humidification is not really necessary. Excessive summertime dehumidification has also been reported on occasions, perhaps a consequence of control faults.
